4 Seasons Home Inspection

Property Condition Assessment Report Data

Address, Berkeley Heights, NJ

File Number: 1154_ClientFileNumber

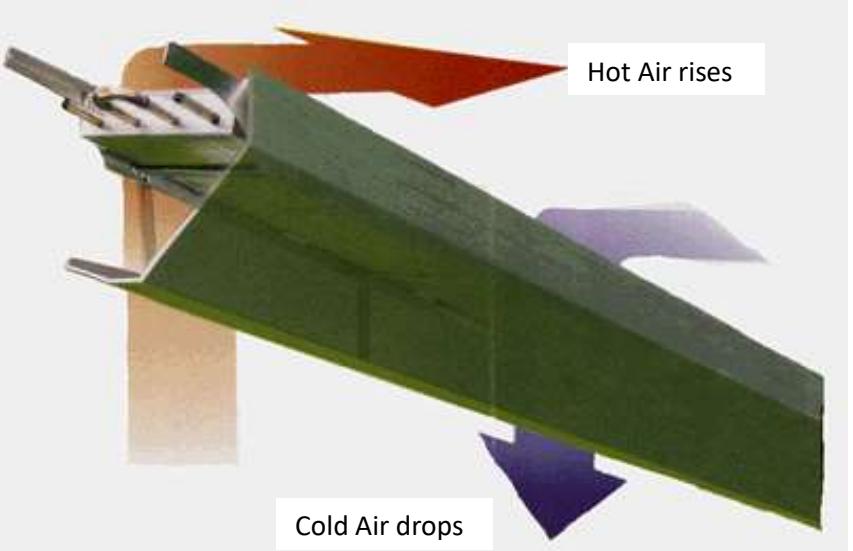
(photo 16)

<p>Photo # 16- Typical design of a Valance cooling system used in conjunction with the Trane Odyssey split cooling system</p> <p>Location of Valance allows for natural convection; cold air drops and hot air rises.</p> <p>System has condensate drip tray that helps dehumidify the air during operation.</p>

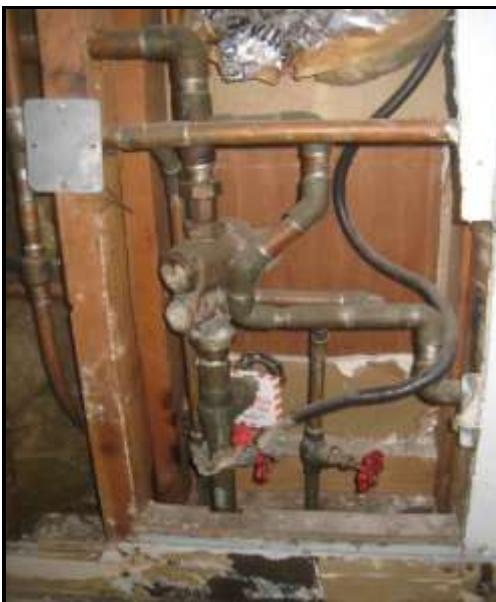
(photo 34)

Photo # 34- Men's room plumbing access panel. Water main tagged with ID card (orange & white). Other shutoff valves service the kitchen and hot water heater.

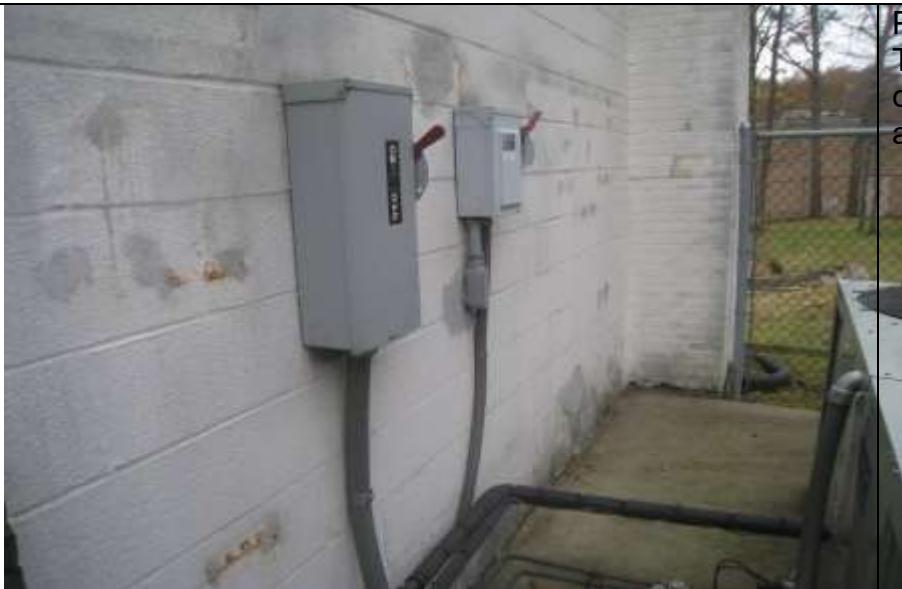
Photo # 37- Disconnects for Trane split single and dual compressor outside in fenced area on east rear wall.

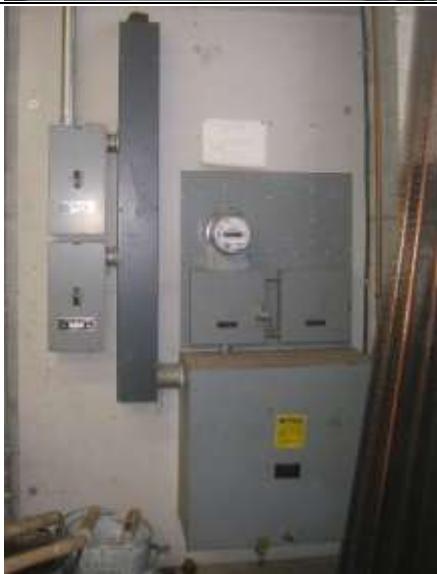
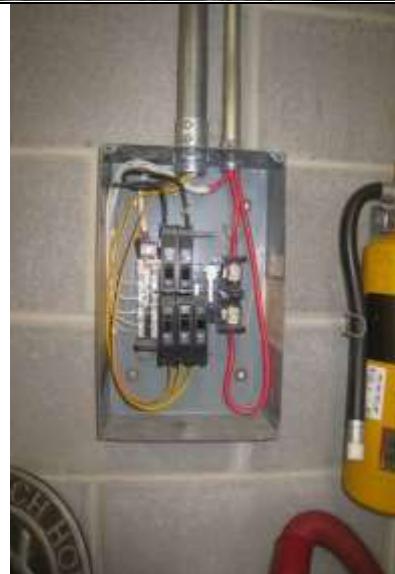
Photo # 38- Main electrical meter and 1 and 3 phase 200 amp disconnects for building.

Sub panel in same room, some CB's (circuit breakers) not in use; panel serviced the Lab areas and associated testing equipment.

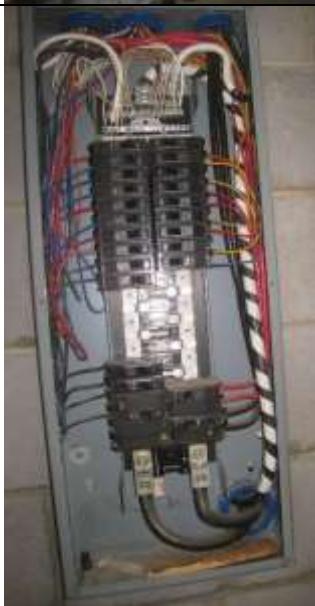
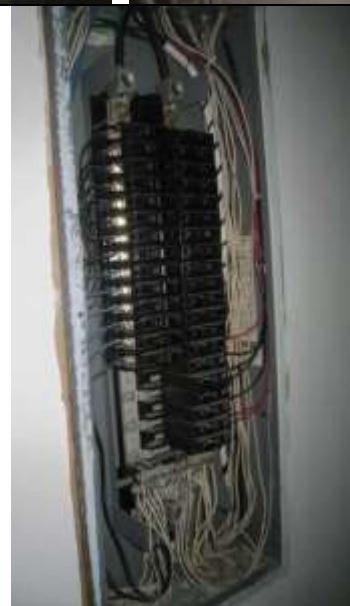
Photo # 39- Sub panels in receiving dock area and office hallway.
