4 Seasons Home Inspection, LLC

Mr. and Mrs. New Construction
Street Address
Township, New Jersey zip code

Inspection Date: July 15, 2009 9am-9pm
Client Name: Client Name(Emails to send reports)
Inspection Address: Street Number, City, NJ
Inspected by: Linda Geczi home inspection lic. #24GI00061500

Detailed Summation begins on pg 5-23 w/pictures

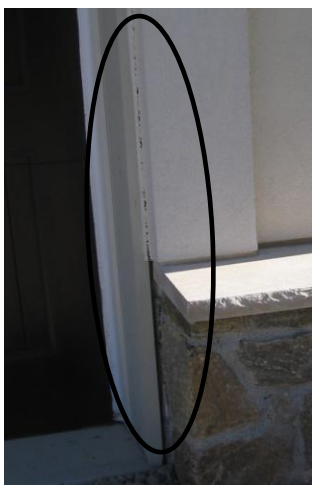
Figure 19 Examples of gaps around house, trim, railings and stone

- 1.) Gutters leaking at corners, seams, junctures and spillage along main runs- Have gutters evaluated & corrections/repairs made. Soil ruts visible and stains on siding or EIFS.
- 2.) Recommend Structural engineer evaluate outcrop off rear kitchen; cracks
- 3.) All gaps, mortar and cracks on cladding & trim needs to be properly sealed/evaluated

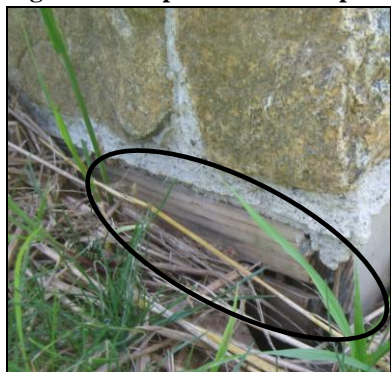
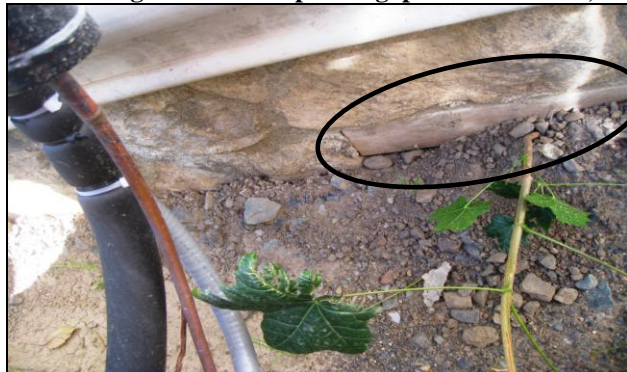
Figure 20 Wood forms left under stone and in contact with soil(siding & retaining walls)

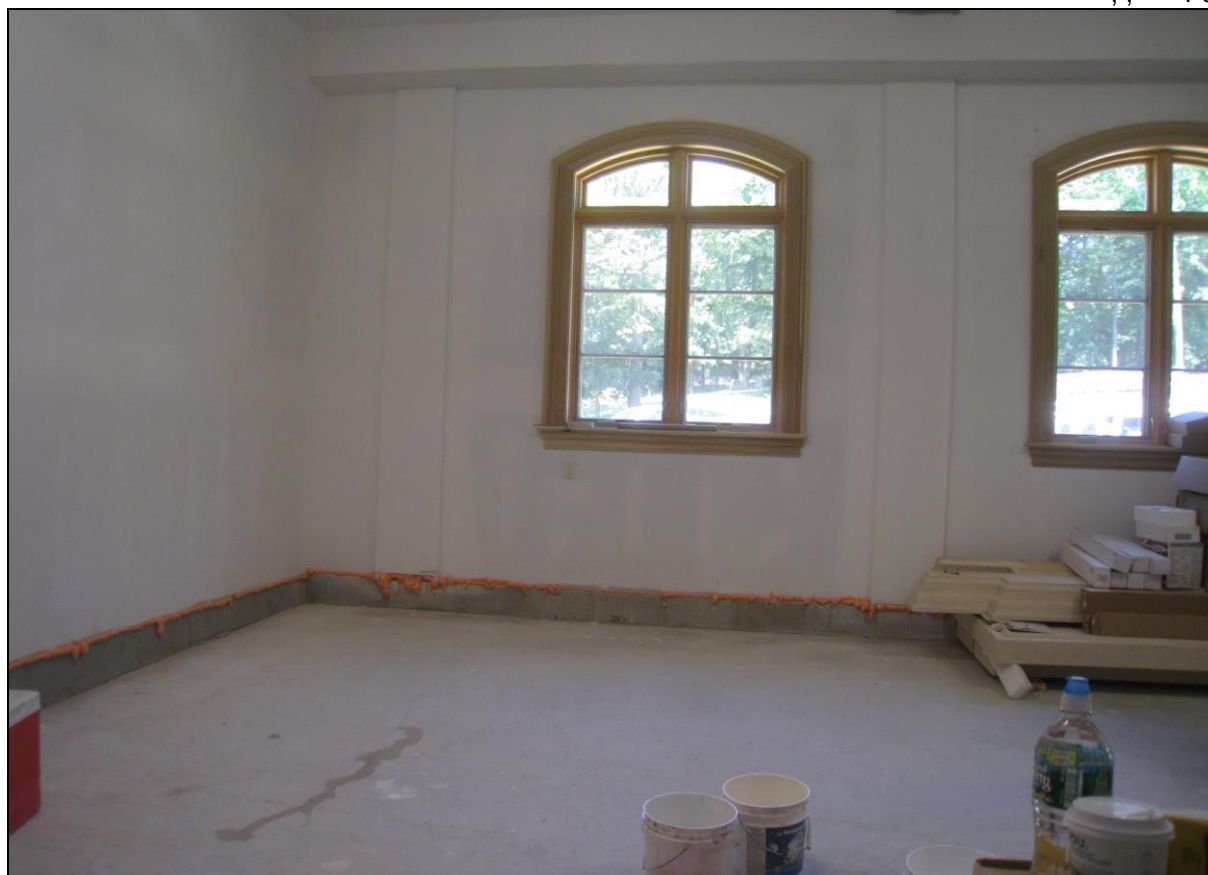
EXTERIOR/ELECTRICAL/A/C/HEAT PUMP/GARAGE : All A/C condensers were not level and sitting on pads above negative grading. Recommend leveling for proper fluid level and intended operation. Recommend correcting grading and level all condensers for proper appliance operation. Secure loose electrical wire to condenser by rear 3 units. There are several mortar cracks on archway and cement block trim details; have properly sealed. Sprayed expansion foam is not recommended. Proper gasket material on sills and caulking is always recommended. Expansion foam shrinks and rots over time and will attract wood destroying insects; termite and carpenter ant. There were live carpenter ants around property and some dead ant bodies in house on tiled flooring. Recommend having a licensed pest company treat and obtain the paperwork and warranty. Very large garages may be subject to local rules for heat sensors or other fire sensing or suppression equipment; check with local fire marshal. There were live yellow jackets around garage and wasp nests attached on cornerstones of garage. Left front GFCI outlet was very loose; correct. GFCI in left two garages resets in the sub panel in prep kitchen just past the laundry area off hallway. Screen missing in garage; add. Some of the cracks handles on windows were loose or lifted out of position when windows tested; correct where needed. Contact Pella manufacturer to see if under warranty and for local service representative. The right garage has power to garage door openers controlled through the GFCI outlets on wall; not recommended to avoid accidental tripping and losing power to door opener. There are some loose white wires near garage doors; further evaluate. Wood railing on steps to hallway by half bath is very loose; secure for safety.

Figure 23 Loose wires by garage doors; further evaluate. Expansion foam everywhere; not recommended.

- 1.) A/C condensers not level, loose wires in rear grouping.
- 2.) Expansion foam everywhere in garage; not recommended

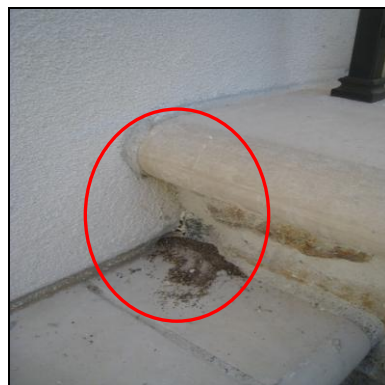
Figure 42 A, B, C & D Indication of leaking gutters and spillage marks. Ruts in soil below.

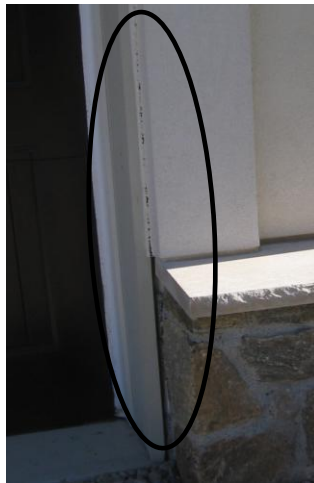
Figure 46 Examples of gaps around house, trim, railings and stone

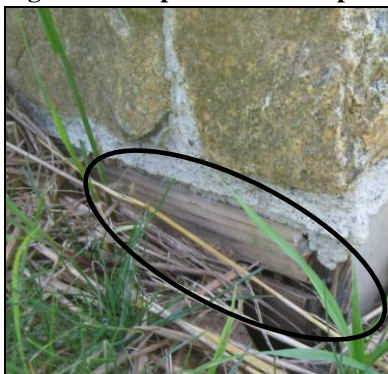
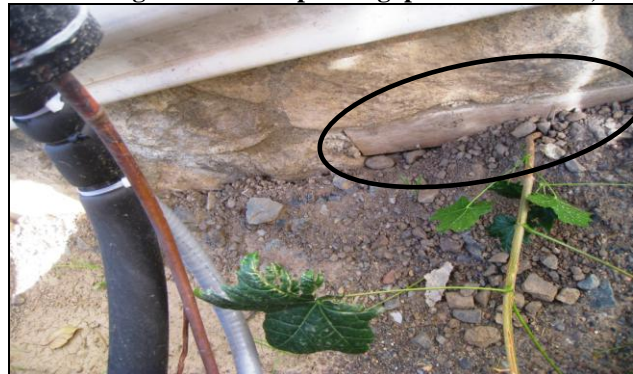
Figure 47 Wood forms left under stone and in contact with soil(siding & retaining walls)

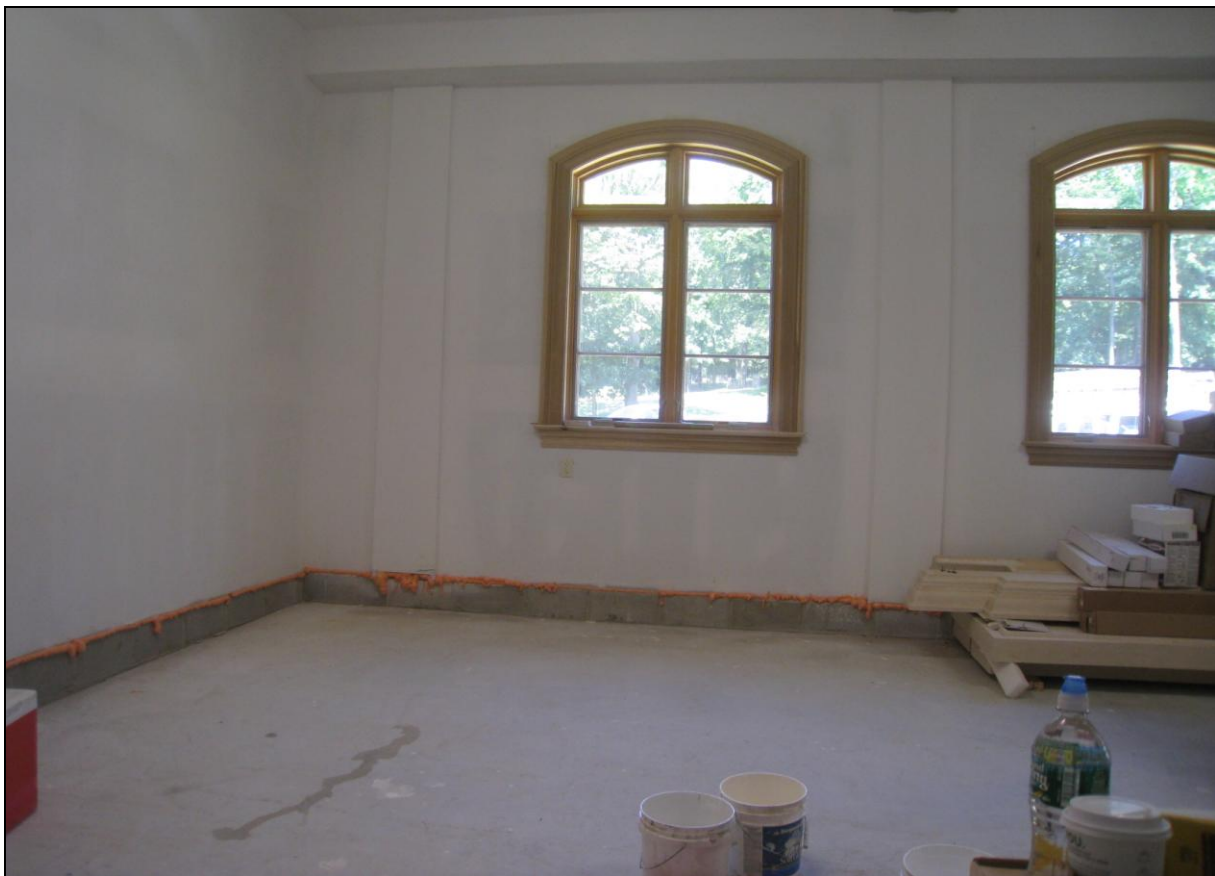
Figure 50 Loose wires by garage doors; further evaluate. Expansion foam everywhere; not recommended.
